These errata apply **ONLY** to Spartan-3 XC3S1000 and XC3S1000L FPGAs, including both production devices and engineering samples. These errata **DO NOT** apply to any other Spartan-3 FPGA. If using a different Spartan-3 FPGA, check for errata specific to that device.

Devices Affected by This Errata

Hardware Errata Summary

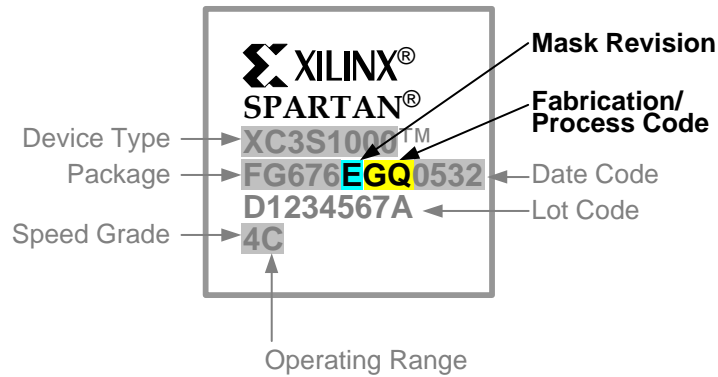
Figure 2: Spartan-3 FPGA from UMC 300 mm facility with “GQ” Fabrication/Process Code Marking

This issue only applies to those designs using the Readback feature on the XC3S1000 or XC3S1000L FPGAs shown in [Table 5](#) with a “GQ” Fabrication/Process Code marking, as shown in [Figure 2](#).

The readback feature is not available for the devices indicated in [Table 5](#).

XC3S1000 FPGAs with an “FQ” Fabrication/Process Code marking fully support the Readback feature. Similarly, XC3S1000 or XC3S1000L FPGAs with an “EGQ” Mask/Fabrication/Process Code marking and with a Date Code of “0532” or later fully support Readback.

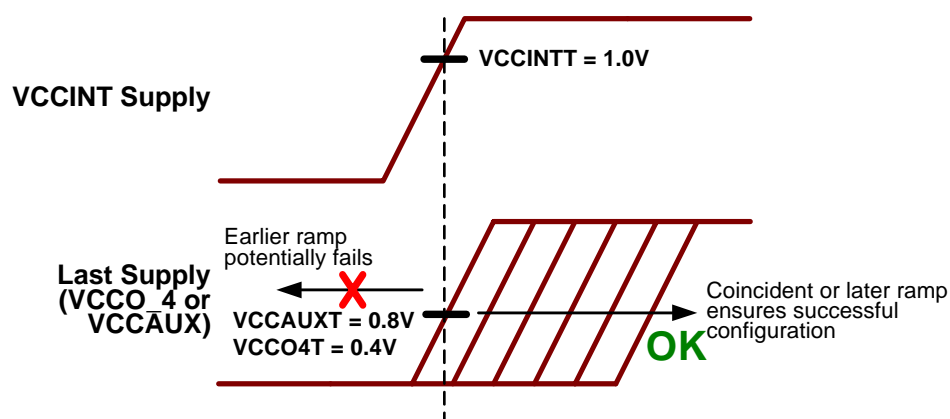
Figure 3: Requirements when VCCINT is not the Last Supply

In the potentially failing condition, the VCCINT supply must be the last supply to reach its valid POR voltage and the ramp rate must be slower than 500 μ S. When the FPGA fails to configure, the INIT_B remains Low and the FPGA ignores the PROG_B program pin. Even with the worst identified power sequence, actual failures only occur on a small percentage of devices, typically measured in parts per million. The issue is more pronounced at cold temperatures.

OPTION 2: Use a power-on sequence where VCCINT is not the last supply to reach its POR threshold level.

VCCINT must reach its maximum POR threshold ($V_{CCINTT} = 1.0V$) before or coincident with VCCAUX reaching its minimum threshold ($V_{CCAUXT} = 0.8V$). This supply sequence and threshold relationship is illustrated in [Figure 3](#).

Alternatively, VCCINT must reach its maximum POR threshold ($V_{CCINTT} = 1.0V$) before or coincident with VCCO_4 supplying I/O bank 4 reaching its minimum threshold ($V_{CCO4T} = 0.4V$). This supply sequence and threshold relationship is also illustrated in [Figure 3](#).

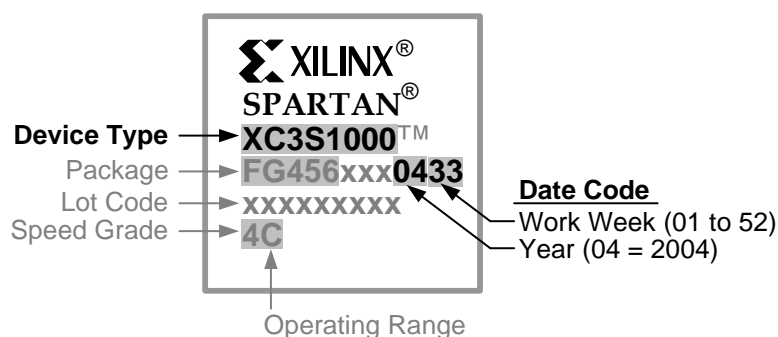
Figure 5: Example Spartan-3 Package Markings

Spartan-3 block RAM internal timing is controlled by settings in the FPGA configuration bitstream. Through yield analysis, new optimal bitstream settings were identified for specific Spartan-3 device types. These new settings improve the block RAM internal timing margin, which consequently improves overall product yield and availability. **These new settings do not affect any timing in the FPGA application**, only internal timing relationships within the block RAM. The specific improved internal block RAM timing path is the relationship between the write-enable timing and the input latch-enable timing.

These new bitstream settings are now the default settings starting with Xilinx ISE 6.3i, Service Package 1, available for download from the Xilinx web site after September 13, 2004. XC3S1000 FPGAs are tested using these new bitstream settings beginning with date codes "0433", corresponding to Work Week 33 of 2004. [Figure 5](#) shows an example top marking for a Spartan-3 FPGA. The relevant fields to identify an affected device are highlighted and include the **Device Type** and the **Date Code**.

Please regenerate any Spartan-3 FPGA configuration bitstreams created using software versions prior to Xilinx ISE 6.3i development software, Service Pack 1. By updating the bitstream, the application can use any existing or future production Spartan-3 FPGA device.
